Investigation of Fire September 1988 Lease OCS-G 1633 Main Pass Block 133

**Gulf of Mexico Off the Louisiana Coast**

by Rufus P. Kirk Felix G. Dyhrkopp Robert C. Lanza William D. Terrebonne, Sr.

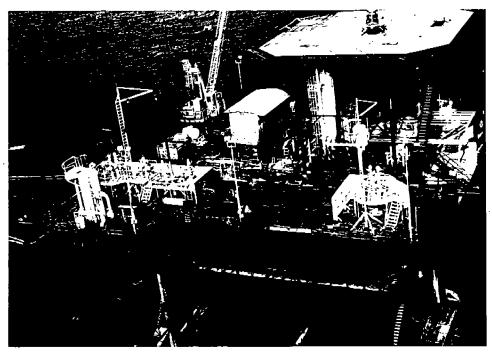
Platform A, Main Pass Block 133

There was damage to the platform throughout most of the lower deck and portions of the upper deck.
